# Manhole Inspection Summary

Manhole # S67G\_\_016MH

Insp Date: **5/27/08 9:04 AM**

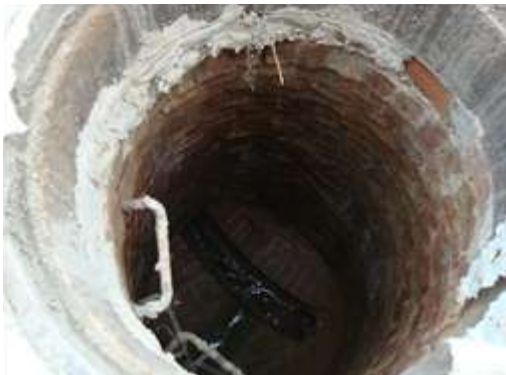
Defect 1

Infiltration: ☐ None ☒ **Joint** ☐ Cracks ☐ Mortar ☐ Roots ☐ Wall

Infiltration: ☐ None ☐ Joint ☐ Cracks ☐ Mortar ☐ Roots ☒ **Wall**

infiltration

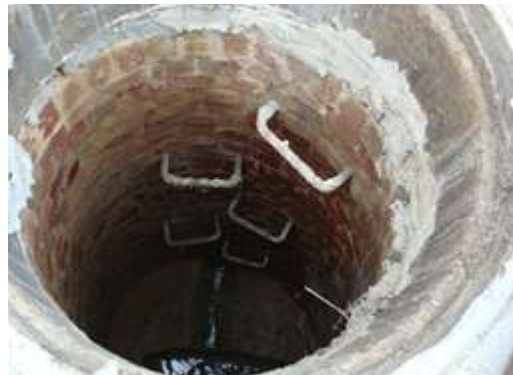
Defect 2

Count: **5** Missing: **0** ☒ **Corroded**

coroded steps

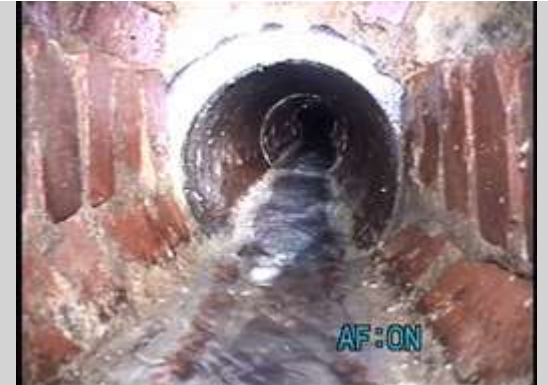
12 O'Clock Outflow

8 in. Circular Gravity Sewer  
Pipe Out @ 12 O'Clock

Pipe Height: **8.4** (in.) Rod and Bar (Angled)  
Pipe Material: **Clay** ☐ Pipe Lined  
Invert Depth: **10.10** (ft.) Flow Characteristics: **Fast**  
Deposits: ☒ None ☐ Mud ☐ Sludge ☐ Debris ☐ Grease  
Silt Depth: (in.) Deposits Extent:  
Infiltration: **None** Pipe Seal Cond: **Sound**

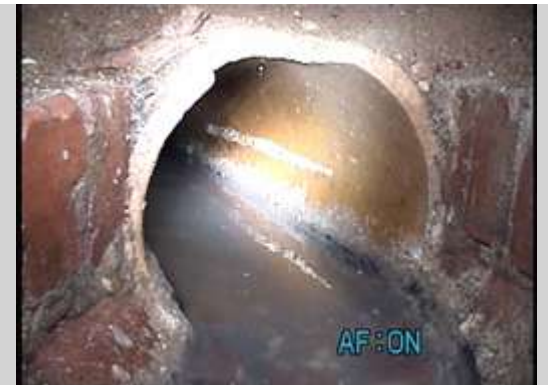
5 O'Clock Inflow

8 in. Circular Gravity Sewer  
Pipe In @ 5 O'Clock

Pipe Height: **8.4** (in.) Rod and Bar (Angled)  
Pipe Material: **Clay** ☐ Pipe Lined  
Invert Depth: **10.00** (ft.) Flow Characteristics: **Fast**  
Deposits: ☒ None ☐ Mud ☐ Sludge ☐ Debris ☐ Grease  
Silt Depth: (in.) Deposits Extent:  
Infiltration: **None** Pipe Seal Cond: **Sound**

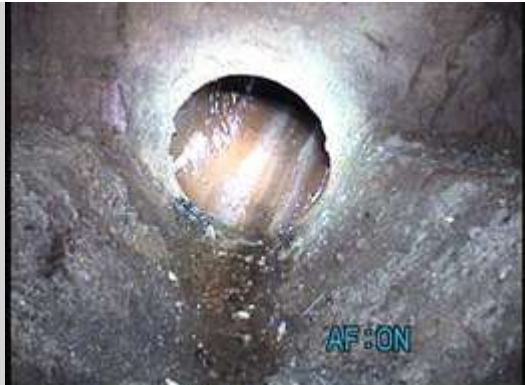
9 O'Clock Inflow

6 in. Circular Gravity Sewer

Pipe In @ 9 O'Clock

Pipe Height: **6** (in.) Rod and Bar (Angled)

Infiltration: **None**

Pipe Seal Cond: **Sound**
